# Manhole Inspection Summary

# Manhole # S45E\_\_063MH

Insp Date: **7/23/08 10:16 AM**

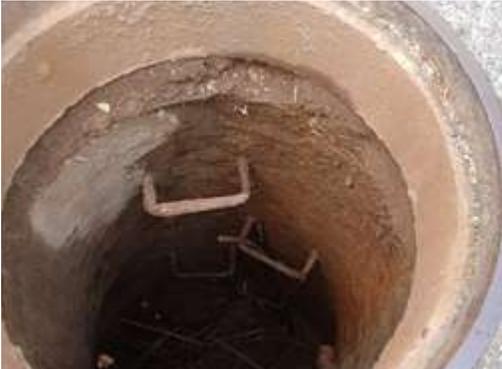
Defect 1

Infiltration:  None  **Joint**  Cracks  **Mortar**  Roots  Wall

Infiltration:  None  Joint  Cracks  Mortar  Roots  **Wall**

Infiltration

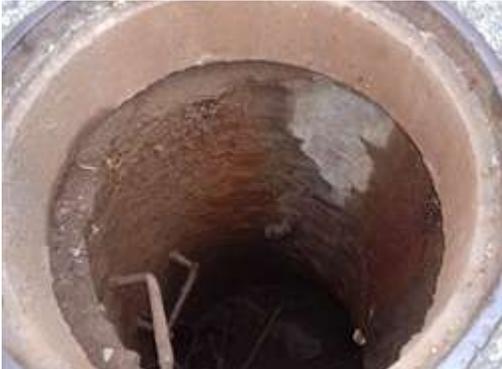
Defect 2

**Frame** Offset: **3** (in.) Condition:  Sound  Cracked  **Leaks**

Frame Leaks

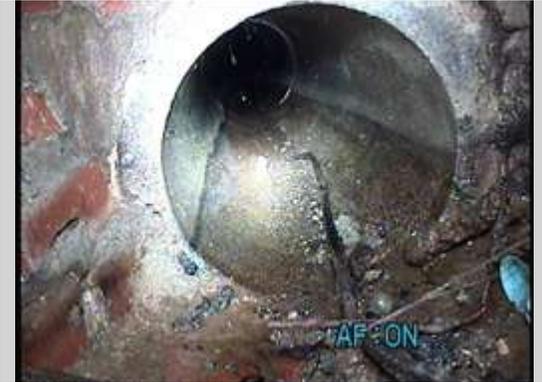
12 O'Clock Outflow

8 in. Circular Gravity Sewer  
Pipe Out @ 12 O'Clock

Infiltration: **None** Pipe Seal Cond: **Sound**
